APPENDIX D: CHANNEL AND RIPARIAN AERIAL ASSESSMENT

DEARBORN TMDL PLANNING AREA

Channel and Riparian Aerial Assessment

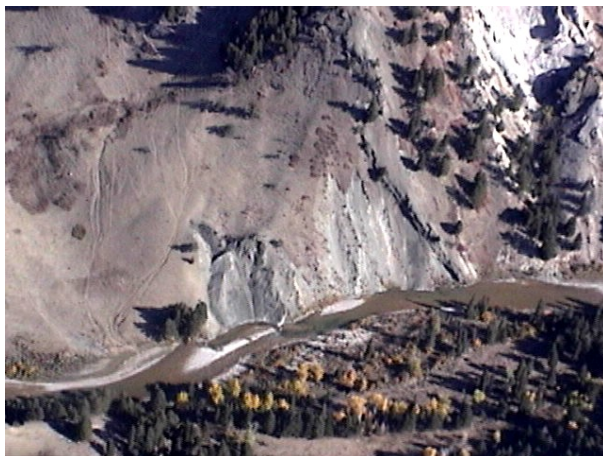
Figure 3-31. Slumps in Dearborn Mainstem Reach 6

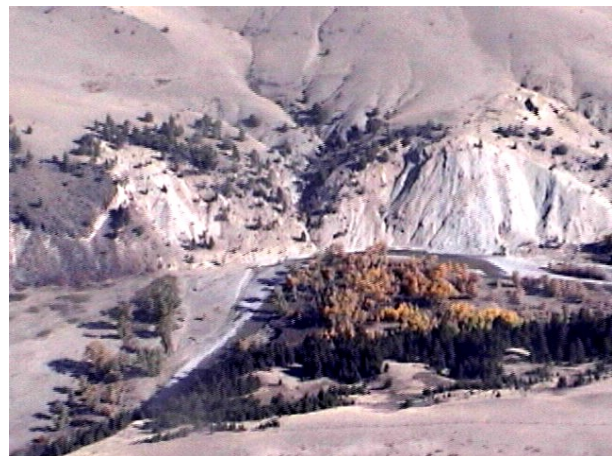
Figure 3-32. Dry Ravel/Rilling in the Dearborn Mainstem Reach 4

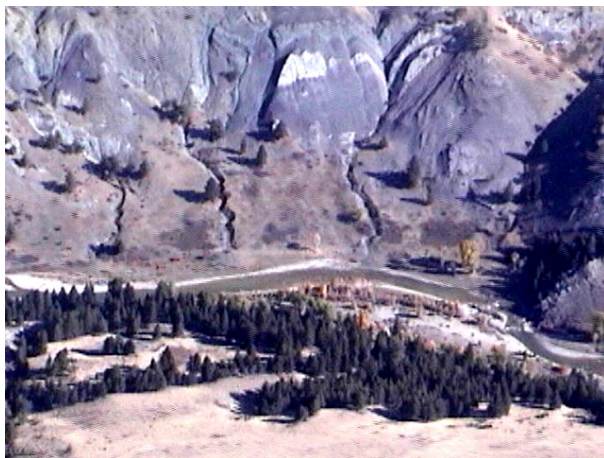
Figure 3-33. Gullies in the Dearborn Mainstem Reach 5

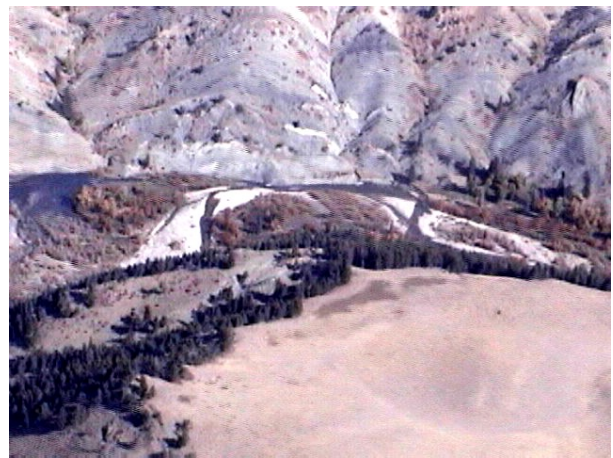
Figure 3-34. Typical Smaller Contributing Drainages to the Dearborn Mainstem

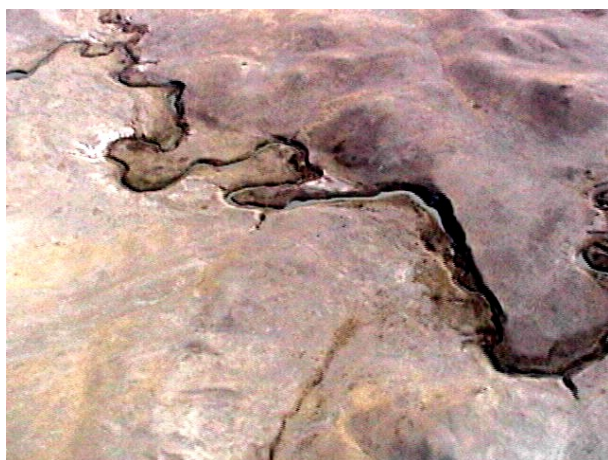
Figure 3-35. Hogan Creek, Tributary to Flat Creek Reach 4.

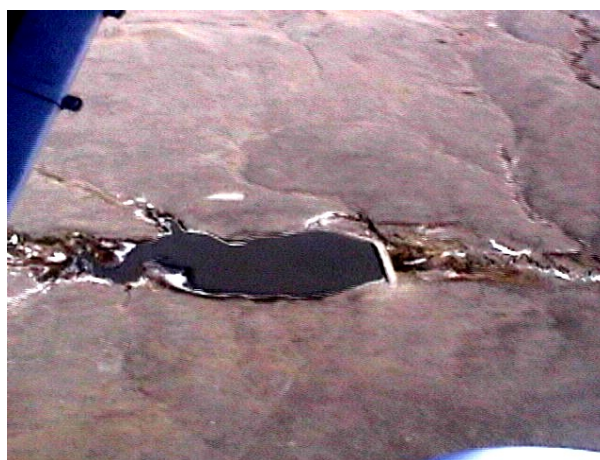
Figure 3-36. Upper Hogan Creek, Tributary to Flat Creek Reach 4.

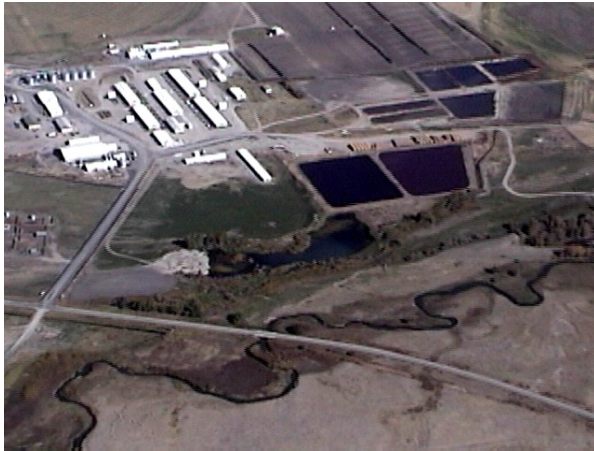
Figure 3-37. Milford Colony

No major anthropogenic point sources for sediment or temperature impairment were noted. The Milford Colony has several lagoons/holding ponds located along the riparian corridor of Flat Creek (**Figures 3-37, 3-38**). Water quality in these lagoons is unknown and potential impacts to Flat Creek could not be determined in this study. The possible influence of these features on water quality may warrant additional investigation, although the potential to affect sediment or thermal impairments is likely to be minimal.
